THE RESTORATION OF MAIN TURBINE BARRING GEAR STOPPAGE ISSUE IN THERMAL POWER STATION

BASING ON CASE STUDY WORKS PROPOSED FOR RESTORATION OF MAIN TURBINE BARRING GEAR STOPPAGE ISSUE

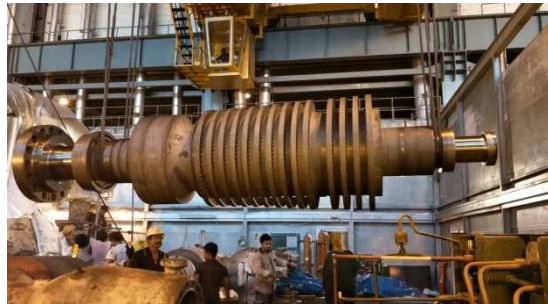
Figure 1

- Steam Flow path measurement of HP turbine.
- HP rotor removal from inner casing and shifting for alumina blast cleaning.
- Removal of seal segments from HP inner casing.

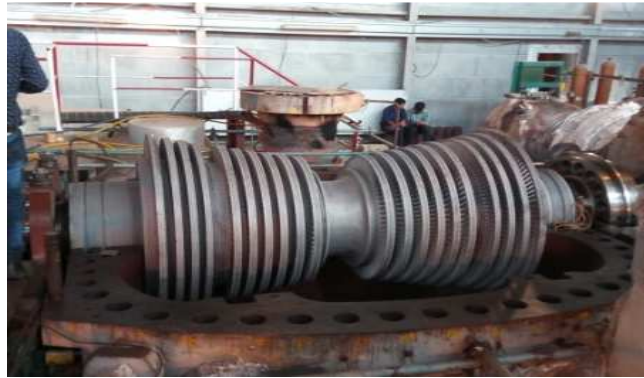
Figure 4

- Dismantling of IPT gland leak off lines .
- Centering of rotor w.r.t outer casing was recording.
- Horn drop of IP casing was recording.
- Loosening of IPT inlet pipe lines joint bolts .
- Dismantling of IPT gland steam pipe lines .
- Roll check and bump check of IPT.
- Removal of extraction pipelines of IPT.
- IPT outer casing P/P bolts loosening.
- Removal of IPT outer casing top half.
- IPT inner casing P/P bolts loosening and Casing removing from position.
- IPT steam flow path clearances recording.
- IPT rotor lifting from position.
- Removal of IPT Bottom half inner casing.
- All the thermocouples connecting to IP inner casing found to be cut.

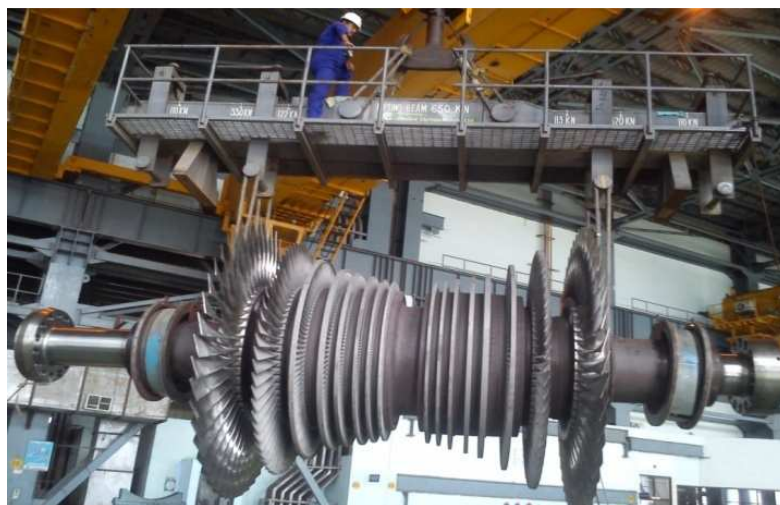
Figure 5

- LPT outer casing lifting from position.
- Roll check of LP inner-outer casing and values were recording.
- Dismantling of LPT inner-outer casings.
- Dummy plates from LP inner-inner casing were dismantling.
- LP inner-inner casing p/p bolts loosening and top half casing dismantling from position.
- Flow path clearances of LP turbine was measuring and recording.
- LPT rotor along with expansion bellows lifting from position.
- LP expansion bellows removing and LP rotor placing on stands.
- Removal of gland seal segments from LP glands.
